SUBJECT: Transistor Failure in Environmental
Control Unit - Case 320

DATE: January 5, 1968

FROM: C. M. Klingman
C. H. Zierdt, Jr. (BTL)

MEMORANDUM FOR FILE

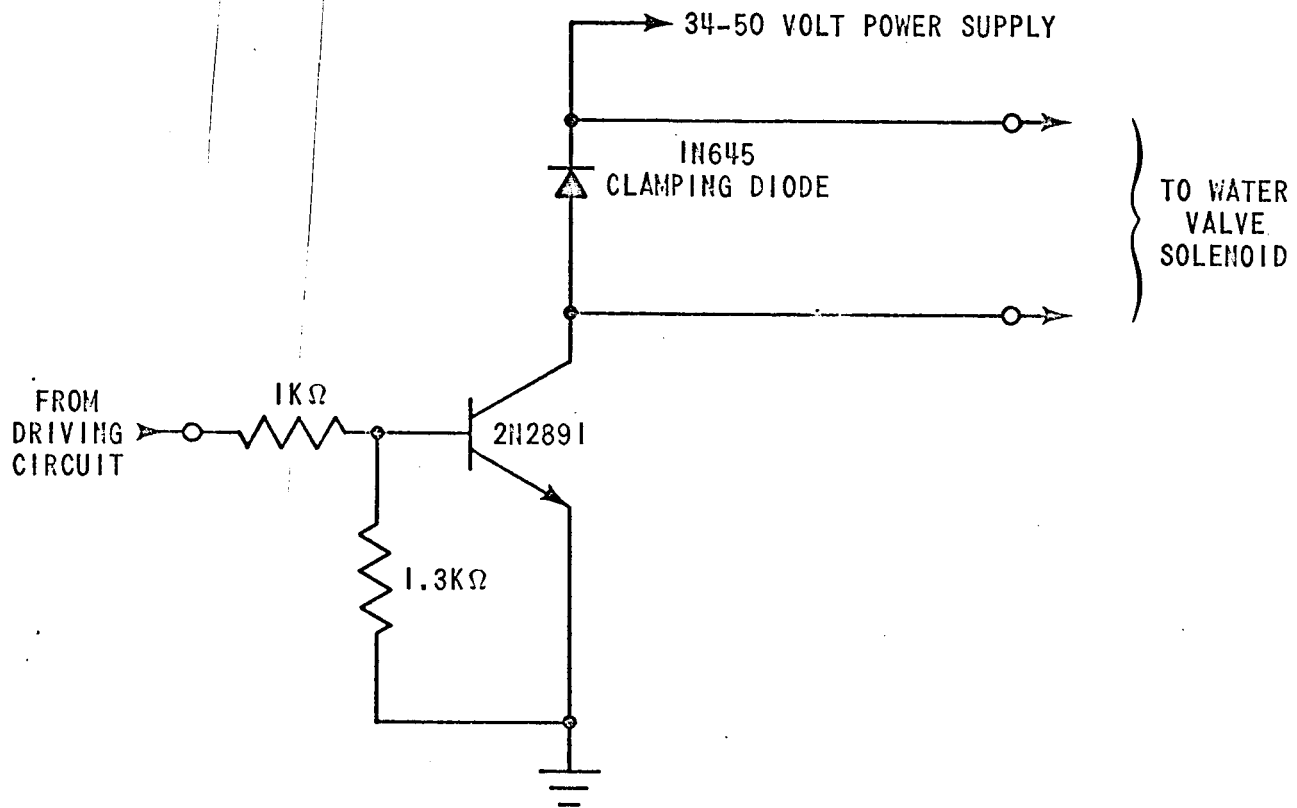
FIGURE 1 - CIRCUIT APPLICATION OF 2N2891 TRANSISTOR

The circuit configuration in which the 2N2891 transistor failed is shown in Figure 1. In performing the analysis of the 2N2891 failure the following data were considered: data available from life tests on this type of transistor chip; data taken on the circuitry, application, and environment; and system data recorded during the time of failure. All are discussed separately in the following paragraphs with associated conclusions based on each set of data. The assessment of the circuit used in Spacecraft 017 follows the discussions of this data.

An open diode circuit would allow the inductive "kick" from the solenoid coil, at turn-off, to be applied to the transistor. This kick would apply sufficient energy and voltage to cause reverse second breakdown. A shorted diode would apply V_{cc}

directly to the 2N2891 collector, with only power supply resistance limiting collector current; the resulting current was estimated to be sufficient to cause forward second breakdown.
